Monitoring Data Record

Project Title: R-2248D – Charlotte Outer Loop COE Action ID: 200131321
 Stream Name: Trib. to Dixon Branch (Site 16) DWQ Number: 011231
 City, County and other Location Information: Mecklenburg County, Charlotte Outer Loop, R-2248D Right of Project Station 13+50 Ramp 2D
 Date Construction Completed: February 2005 Monitoring Year: (4) of 5
 Ecoregion: 8 digit HUC unit 03050103
 USGS Quad Name and Coordinates: _____
Rosgen Classification: Proposed C4 stream type classification
 Length of Project: 548 ft. Urban or Rural: Urban Watershed Size: _____
 Monitoring DATA collected by: M. Green and J. Young Date: 1/25/12
 Applicant Information:
 Name: NCDOT – Roadside Environmental Unit
 Address: 1425 Rock Quarry Rd, Raleigh, NC 27610
 Telephone Number: (919) 861-3772 Email address: mlgreen@ncdot.gov
 Consultant Information:
 Name: _____
 Address: _____
 Telephone Number: _____ Email address: _____
Project Status: _____

UT to Dixon Branch

Site 16

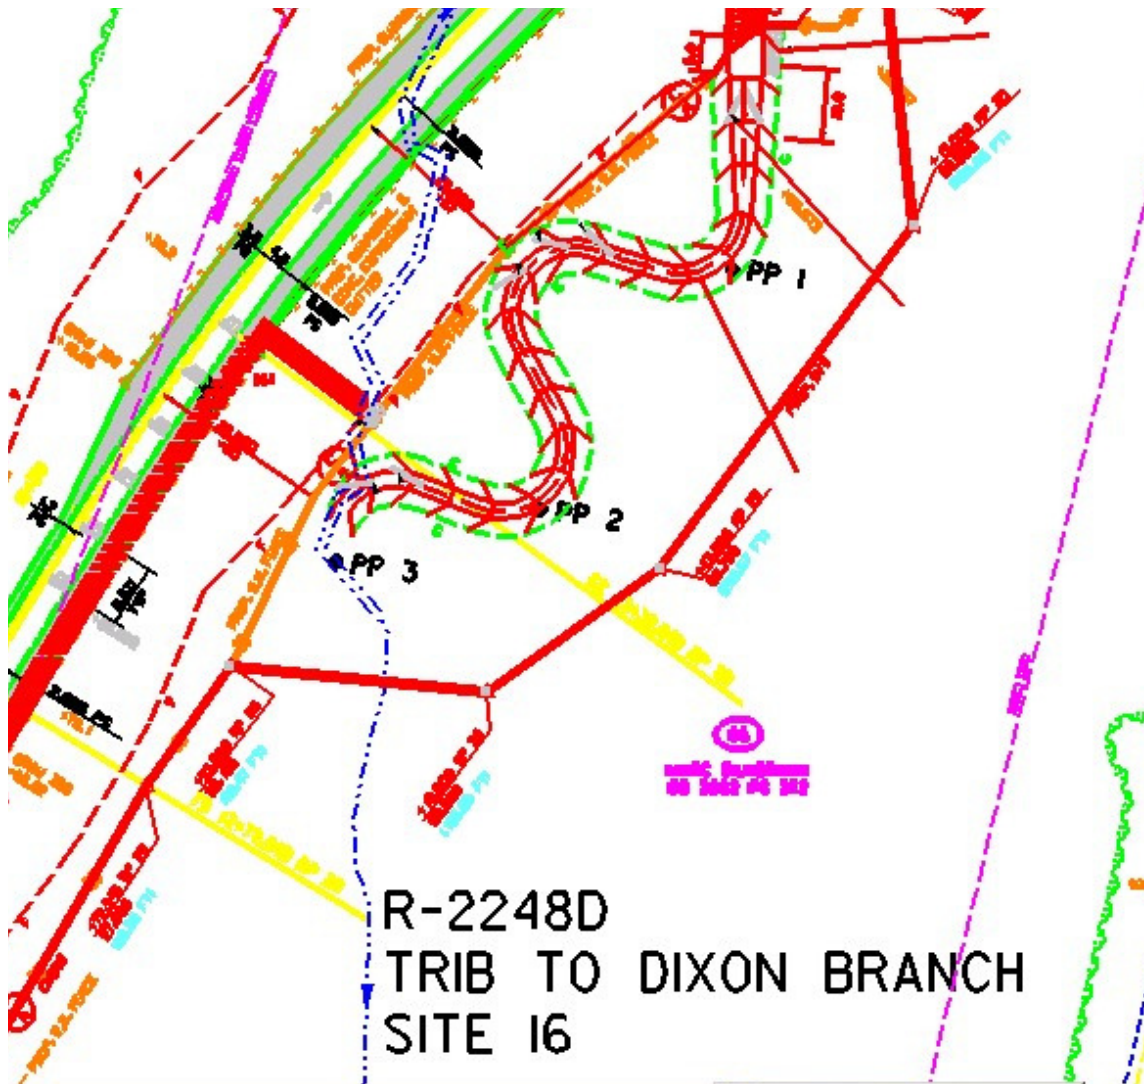
Log Sill #4 (looking upstream)

Date 1/25/12	Between PP#1 and PP#2	Between PP#1 and PP#2	Between PP#1 and PP#2	Between PP#1 and PP#2	Between culvert outlet to PP#1
Structure Type	Log Sill #1	Log Sill #2	Log Sill #3	Log Sill #4	
Is water piping through or around structure?	Water is piping around left side of log sill	Water is flowing over log sill but is also piping around right side	Water is piping around left side of log sill	Water is flowing over log sill	
Head cut or down cut present?					
Bank or scour erosion present?		Right bank has eroded			Bank erosion present
Other problems noted?
